MEMORANDUM

TO: Village of Tuxedo Park

DATE: December 15, 2020

SUBJECT: Preliminary Engineering Evaluation – Department of Public Works Building

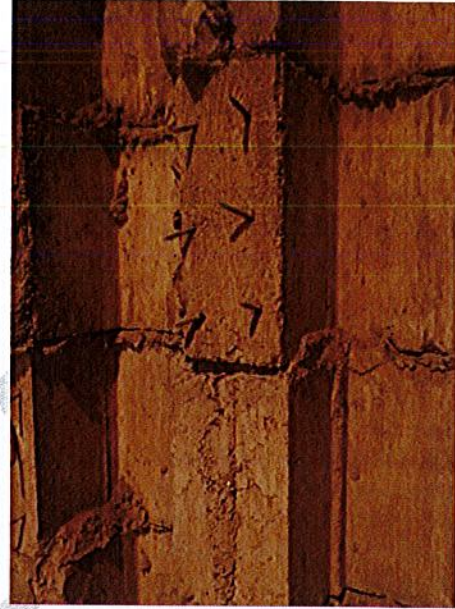
Superstructure: The existing superstructure (walls) are comprised of a single wythe concrete block with open cores facing the interior. The blocks have a horizontal laying length of approximately 24", a vertical course height of approximately 10", and a thickness of approximately 10". The walls are visibly unreinforced, and the blocks appear to have been cast with a wooden nailer block embedded by placing the block in the bottom of the form with nails cast into the block itself. This block provided a place to nail the interior wooden timbers that originally faced the icehouse, but in modern times the timbers are mostly gone, as are many of the blocks, leaving only the embedded nails protruding as a constant hazard to anyone working near the exterior walls. The upper sections of the exterior walls are topped with a hollow core terracotta block to provide natural ventilation – precluding a controllable building envelope.

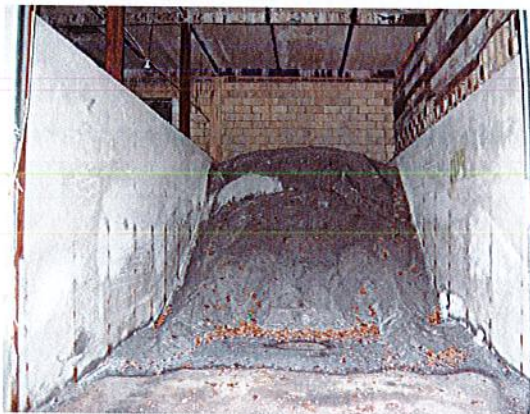
Salt Storage: one bay of the building has been converted to salt storage, and the steel structural elements in this area exhibit deterioration far beyond the rest of the structure.

Conclusion: the building superstructure, although it exhibits corrosion of main elements and cracks in the exterior walls, seems solid and unlikely to change anytime in the near future. The interior storage of salt is causing a rapid deterioration of the adjacent structural elements and needs to be addressed immediately.

2. Salt Storage: the end of the building where the salt is stored is deteriorating far faster than the rest of the building, as evidenced by the corrosion of the steel structural members and the spalling of the concrete roof deck. It is recommended that the Village develop an alternate location outside of the building to store salt, preferably in a covered, secure location. Prefabricated tensioned fabric structures are an inexpensive solution to storing salt that we have used in a number of locations and it would appear that there is adequate space on the site to accommodate a new structure of this type.

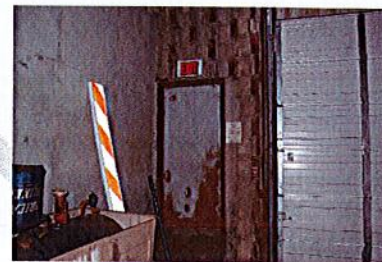
MEP: There are limited mechanical, electrical, or plumbing (MEP) systems in the building, and no fire protection system is present. Heat exists only in selected areas of the building, including the mechanics shop and the staff area on the second floor (served by a single natural gas-fired furnace), plus one remote garage bay (served by a separate natural gas-fired furnace) that reportedly is seldom used. Lighting throughout the building is inadequate, consisting of widely spaced fixtures with limited output. We did not assess the capacity of the electrical system, although the natural gas-fired emergency generator appears to be well oversized.

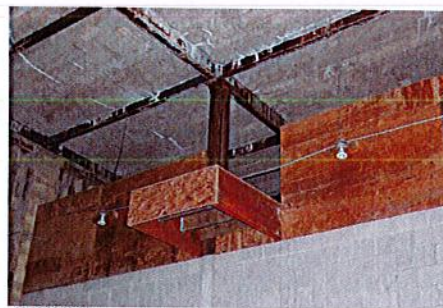
Mezzanine occupancy and egress: The enclosed mezzanine above the shop area has a single means of egress and, the mezzanine above the shop area would be limited to a maximum occupancy of 10 persons under current Code. The smaller storage platform above the interior garage space is not considered occupiable space due to access and headroom limitations.

Stairs and railings: The stairs, railings and guards leading to the staff areas on the mezzanine are not in compliance with current Code dimensional requirements (rise/run/width), intermediate landing, and closed riser requirements. There are no separate guardrails or safety devices at the storage platform or at the open portion of the mezzanine. The short run of interior stairs between the shop area and the restroom/office level is also dimensionally non-conforming and lacks compliant handrails. OSHA regulations may also apply to these and other building elements but have not been specifically identified here.
