Highway-Rail Grade Crossing Review

*Prepared by CTC, Inc., for
Metro-North Railroad*

July 28, 2016

Tuxedo Park, NY
East Village Road
DOT # 263501F, MP 37.30
Port Jervis Line

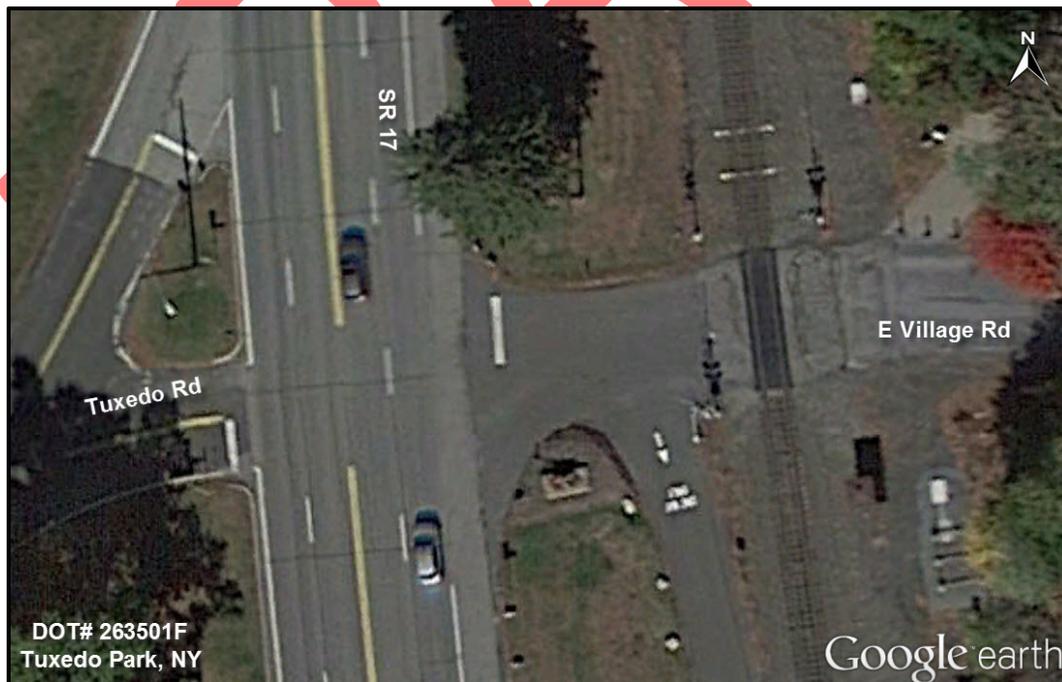
Figure 1 – DOT # 263501F; East Village Road at State Route 17

East Village Road is a two-lane roadway (one lane in each direction) over the crossing approaching the non-signalized intersection at State Route 17.

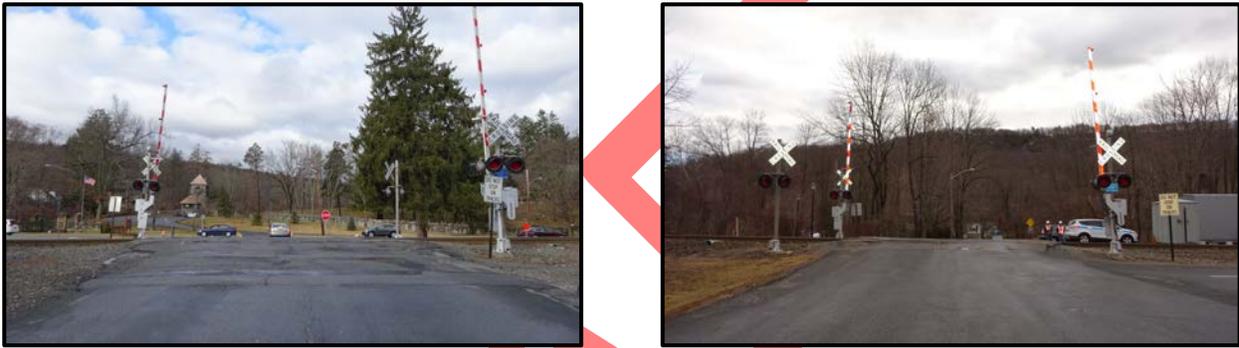
Figure 2 - Westbound and Eastbound View of Crossing

The Railroad operates on one main line track. The railroad active warning system at the crossing consists of railroad flashing-light signals and automatic gates for vehicular traffic in both directions. An additional pair of railroad flashing-light signals is located in the northwest corner of the crossing that face northbound traffic on State Route 17. There is one electro-mechanical bell present. The audible warning bell terminates when the gates reach the horizontal position.

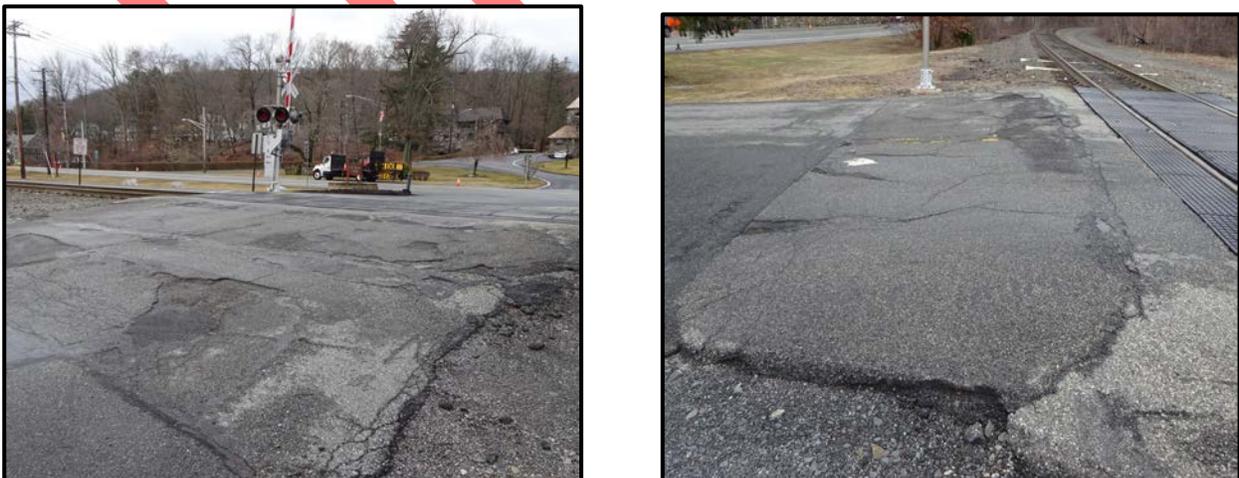
Figure 3 - Roadway Surface

The roadway surface approaching and departing the tracks is in poor condition with depressions, cracking and edge raveling. Motorists traversed the crossing at a reduced speed due to the abrupt height changes. Scarring of the pavement from vehicles is visible.

Traffic lane widths over the crossing are as narrow as 15 feet with virtually no shoulder over the tracks. The measured grade approaching the crossing is an average of 5.5%.

- **Evaluate the roadway/sidewalk at the crossing to determine if the sidewalk widths can be expanded to better accommodate pedestrians traveling over the crossing.** As part of the crossing surface replacement, sidewalk areas need to be adjusted to provide for a level walkway over the tracks to the greatest degree possible. Widening the sidewalk over the crossing is recommended.
- **Evaluate the roadway surface to address the uneven road / track condition.** Repaving of the roadway should be considered and improvement of the roadway grade approaching the crossing, if feasible.
- **Implement tubular markers along edge of pavement to help guide motorists over the crossing and prevent turns onto the railroad right-of-way.**

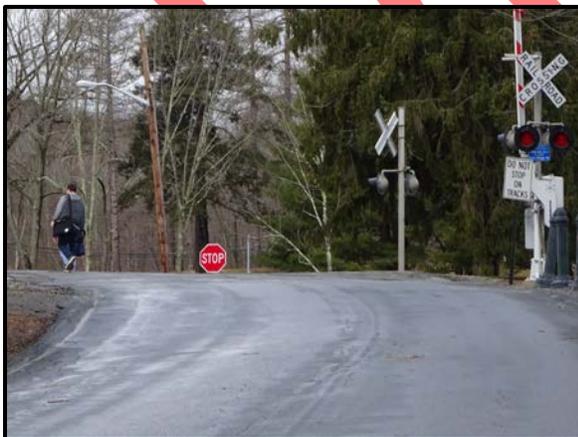
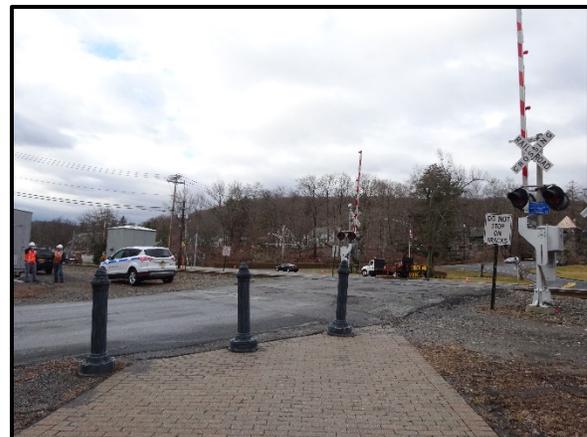
Figure 4 - Pedestrian Crossing

Currently there are no pedestrian treatments or sidewalks at the crossing. Pedestrians must cross the roadway and grade crossing to reach the station platform from the remote parking lot located on the north side of the roadway. The remote parking lot exits via a pedestrian stairway at the edge of the roadway on the north side which no further pedestrian designated pathway to access the station.

- Consider installation of a sidewalk and ADA accessible pedestrian ramp on the north side of East Village Road and connect with a crosswalk at the intersection of State Route 17. Fencing will be needed to force pedestrian to use the provided pathway and not meander across the roadway. A designated path could then be provided from the southeast corner of the intersection at State Route 17 to the station as shown in figure 10 below.

- Implement a pedestrian emergency exit route behind the gates to allow pedestrians to escape the tracks without resorting to entering the traveled roadway or lifting the gate. The existing sidewalks and location of automatic gates leave pedestrians stranded

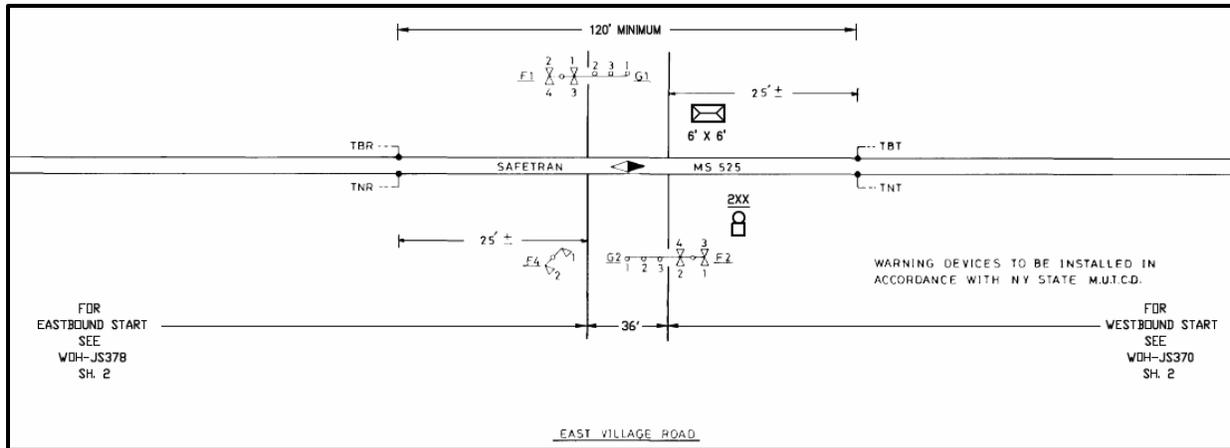
Figure 5 - Circuit Plans

Trains approaching, slowing and stopping at Tuxedo Station activate the warning devices at the grade crossing. As a result, long warning times much greater than the designed warning time of 30 seconds were observed. The vehicular traffic and pedestrians associated with the station stop cause congestion and queuing of vehicles at the crossing.

- **If a traffic signal is installed, update the railroad equipment, circuitry, and active warning devices to accommodate the requested preemption interconnect and timing at the Agency's request.** Upgrade existing equipment to provide advance preemption and interconnection to the traffic signal system. Also a thorough review of operating practices, maximum authorized speed and any civil speed restrictions in effect should be conducted to better understand the nature of the longer warning times. Because of the nearby station stop, longer warning times may be unavoidable.

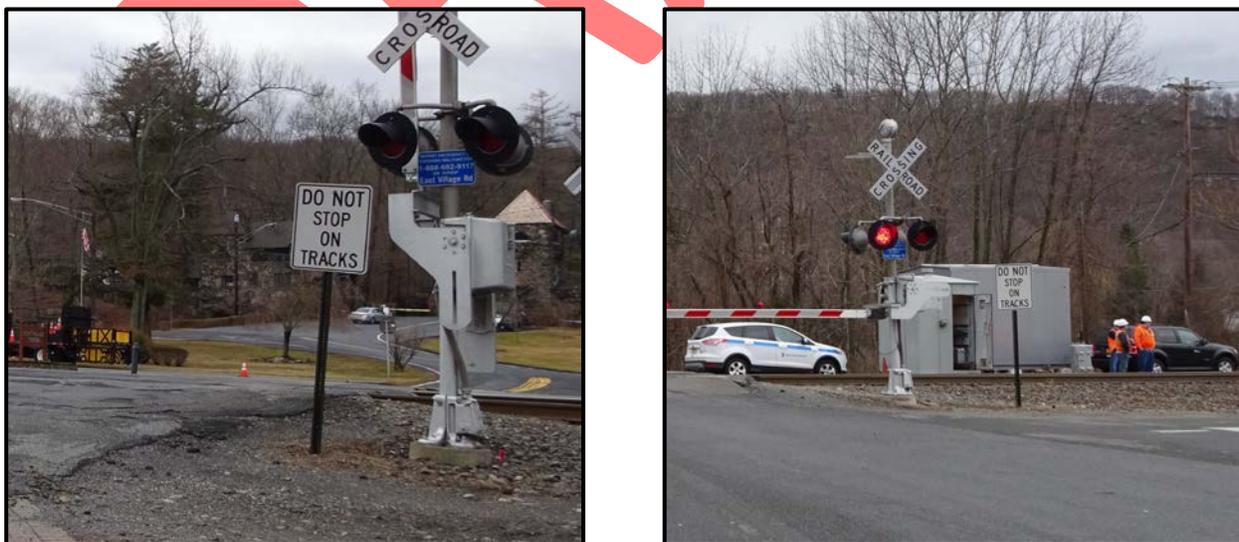
Figure 6 - Do Not Stop on Tracks sign

“DO NOT STOP ON TRACKS” signs (R8-8) are visible to motorists approaching the intersection and crossing from all approaches. Only one grade crossing warning sign (W10-1) is currently installed for westbound traffic.

- Review installation of low ground clearance warning sign (W10-5) for eastbound East Village Road and modify for proper installation height in accordance with the MUTCD.
- Consider installation of intersection advance warning signs (W10-2) for northbound and southbound State Route 17 in accordance with the MUTCD Chapter 8, Section 8b.06.
- Replace the existing “DO NOT STOP ON TRACKS” signs (R8-8) with New York Standard “STATE LAW - DO NOT STOP ON TRACKS” signs (NYR 9-5) and locate the new signs downstream of the tracks for each approach for improved visibility. Vehicles may extend over the tracks based on the existing operation and the installation of these signs provides additional emphasis to alert road users not to stop on the tracks (Refer to the MUTCD, Chapter 8B, Section 8B.09).

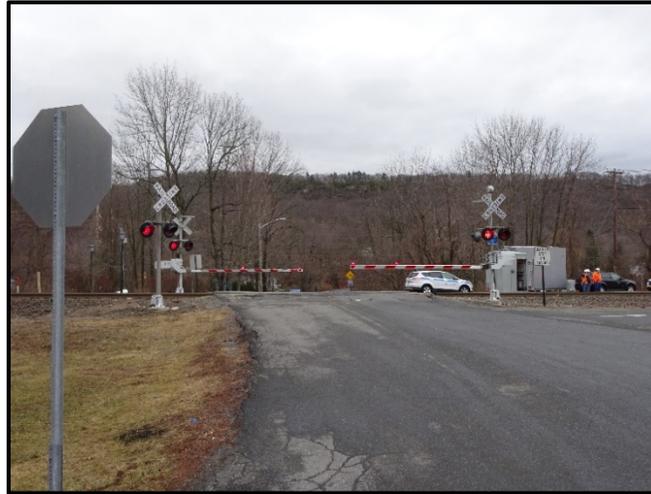
Figure 7 - Pavement Markings

It appears from Google Earth imagery that some pavement markings were installed at one time. However, no evidence was found in the field inspection of previous markings.

- Re-install or refresh the railroad pavement markings in advance of the highway-rail crossing. The railroad crossing pavement marking symbol, lane lines, and stop line should be installed in accordance with MUTCD Chapter 8, Section 8B.27. The advance railroad warning signs may need to be relocated based on the placement of the railroad pavement marking symbols.
- Install edge lines and double yellow centerline through the crossing to help guide motorists over the tracks.

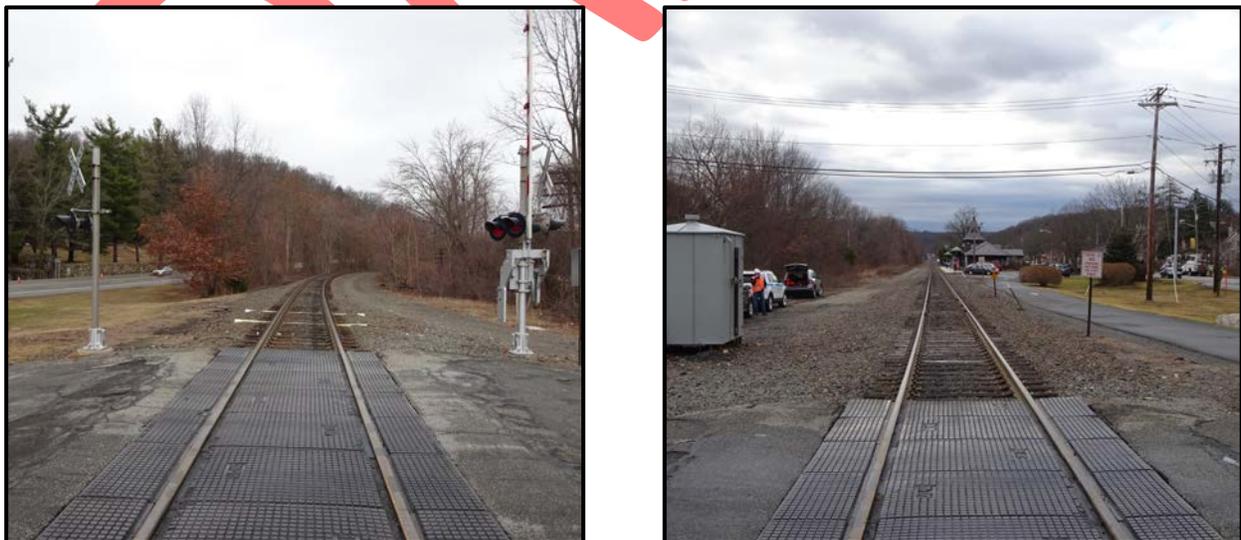
Figure 8 – View of Tracks

The current railroad warning system is a motion detection track circuit. Detection and activation of warning devices occur as soon as the train enters the circuit. Excessive warning times exist when trains approach and stop at the Tuxedo Station.

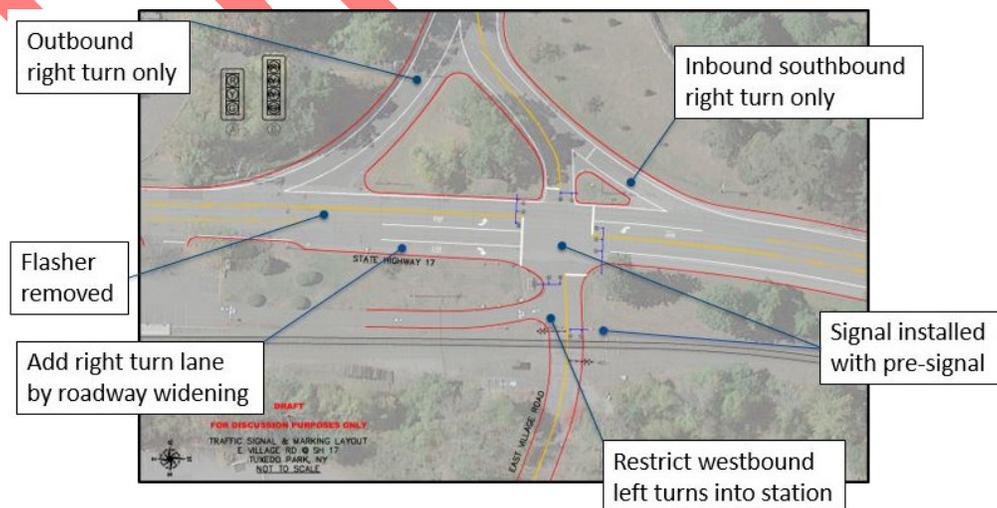
Figure 9 - Traffic Signal and Restriping

- **Consider the installation of a traffic signal at the intersection of East Village Road and State Highway 17 to provide a track clearance movement for the tracks. Due to the steep grades approaching the crossing, a pre-signal should also be installed. Reconfiguration and realignment of the entrance to Tuxedo Road may be required along with State Highway 17 re-striping. A conceptual design is shown in the figure below.**

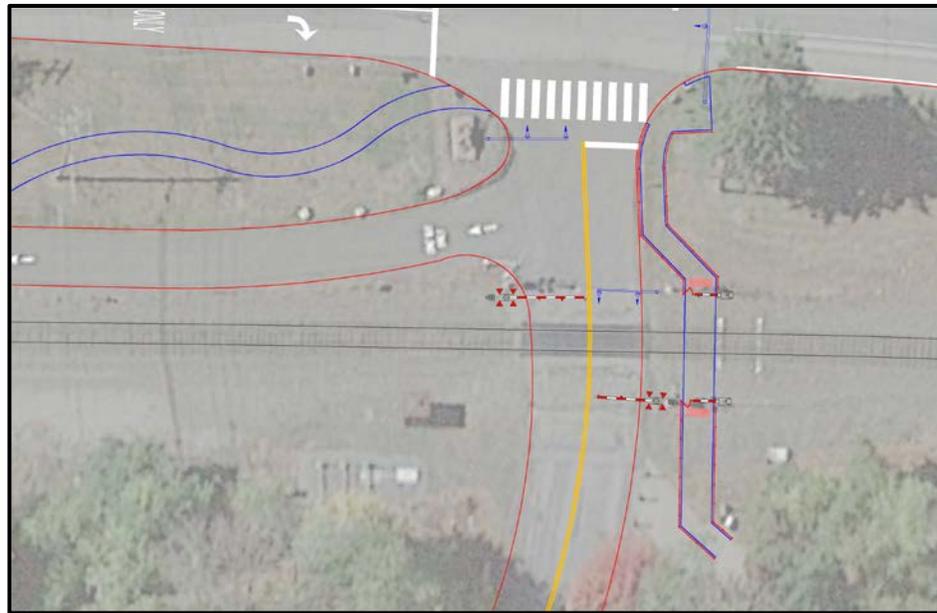
Figure 10 - Pedestrian Gates and Sidewalks

between the lowered gates within the minimum track clearance distance. This forces pedestrians to enter the roadway and walk around, lift the gate or walk under the lowered gate. Proposed new language for the next edition of MUTCD recommends that sidewalks be relocated behind the roadway gates. Fencing and pedestrian gates are then used to control pedestrian access while still allowing for an escape route to prevent stranding pedestrians between lowered gates.
