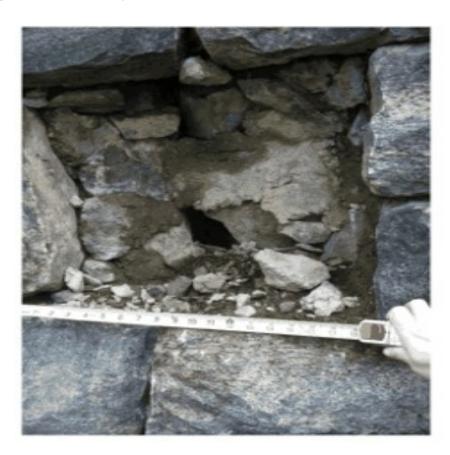
1. On March 5th, a stone, approximately 12" x 16", fell out of the wall along the Causeway.

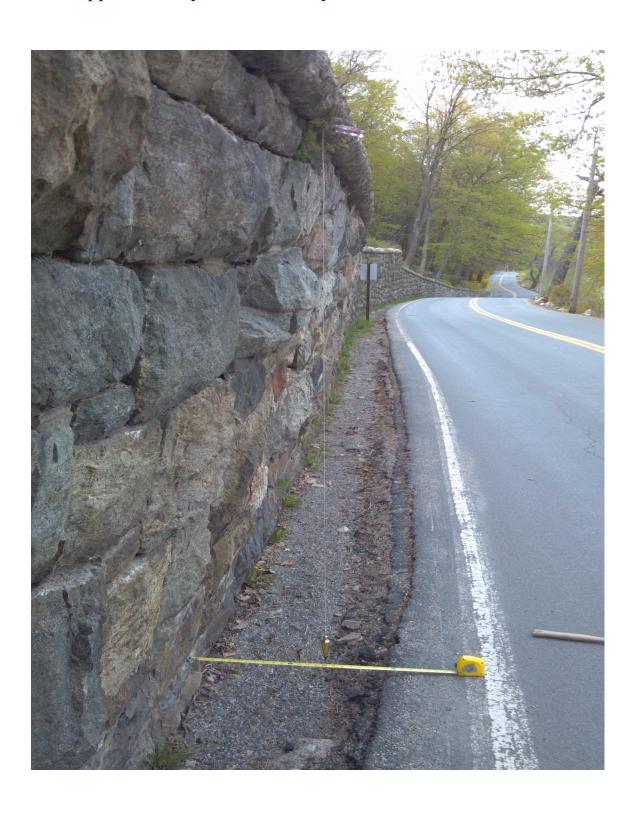
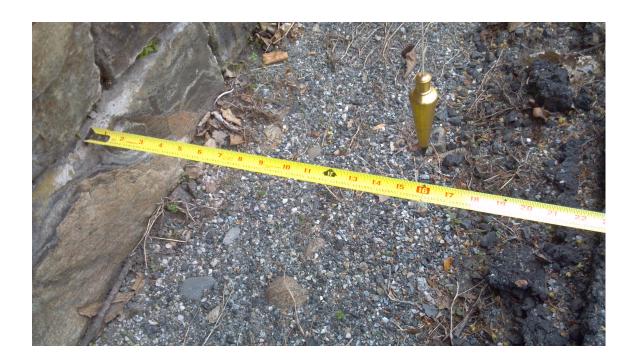
2. At the location where the stone was dislodged, the wall has a significant lean toward the roadway. The lean was later measured to be approximately 12" to 14" beyond vertical.

- 4. On March 11<sup>th</sup> a structural engineer from the Village engineer's firm (Weston & Sampson) issued a written report of his first-hand observations and findings. The Village's engineers determined that the wall had a "minimal to no factor of safety," and "posed a threat to public safety" if the Causeway were to be re-opened. A second engineering firm (O'Brien & Gere) was then engaged, to provide an independent second opinion. The second engineering firm confirmed the Village engineer's conclusion, and issued its finding on March 14<sup>th</sup> that the "wall rotation and horizontal displacement clearly indicates that it [the wall] has failed." They further concluded that the wall will eventually collapse and, although there was no reasonable way to predict when it would do so, a collapse could be initiated by even "a modest increase in wall loading such as from an elevated groundwater level behind the wall resulting

- 5. The Village engineer also noted that the distinct and continuous horizontal joint approximately 3 feet above the roadway indicates that the original wall was likely three feet in height and was subsequently added to, and filled behind, to achieve the present 8-foot wall that presently exists in this area.

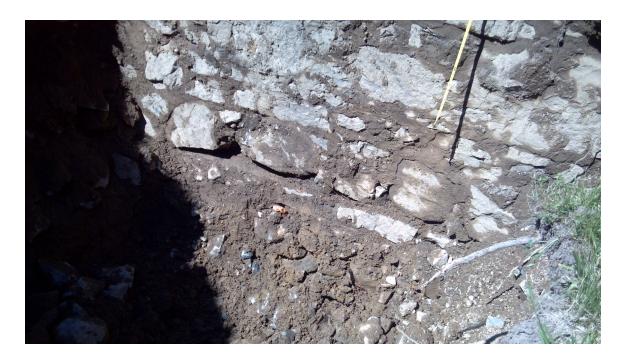
12. During the next several months the Village and Ms. Booth had several discussions to try and come to a mutual compromise to resolve the situation, but were unable to come to an agreement. During this time a test pit was excavated with Ms. Booth's permission on June 4<sup>th</sup>. Upon viewing the excavation the Village engineer advised the Village that their opinion remained the same.

13. The Village engineers were then asked to begin preparing plans and specifications to dismantle the affected section of the wall, rebuild it with a structurally sound wall including necessary soil erosions control measures and proper drainage, replace the stone face of the wall using the same stones as removed, and restore Ms. Booth's property to its present condition.
